MINISTRY OF TRANSPORTS AND INFRASTRUCTURE
ROMANIAN RAILWAY AUTHORITY - AFER

ROMANIAN RAILWAY INVESTIGATING BODY

INVESTIGATION REPORT

for the railway accident in Railway Station CORABIA occurred on 21.02.2011

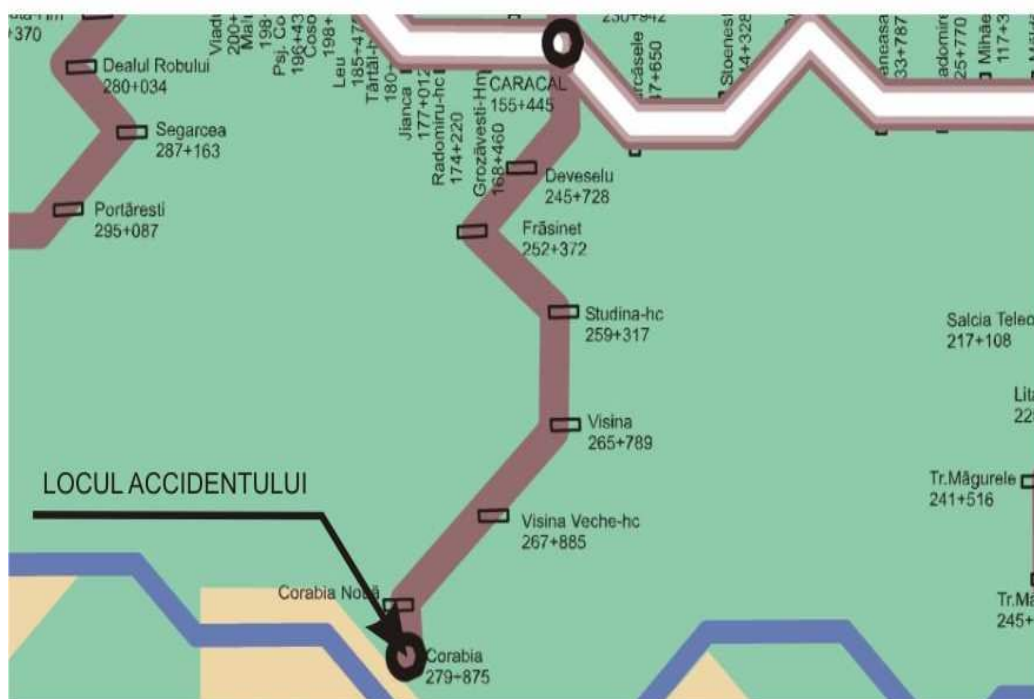
photo no. 1

The site of the railway accident is located in the running section of the Branch of the Railway County Craiova on the hauling section non interoperable Caracal – Corabia rented by SC RC-CF TRANS SRL Braşov (photo 1).

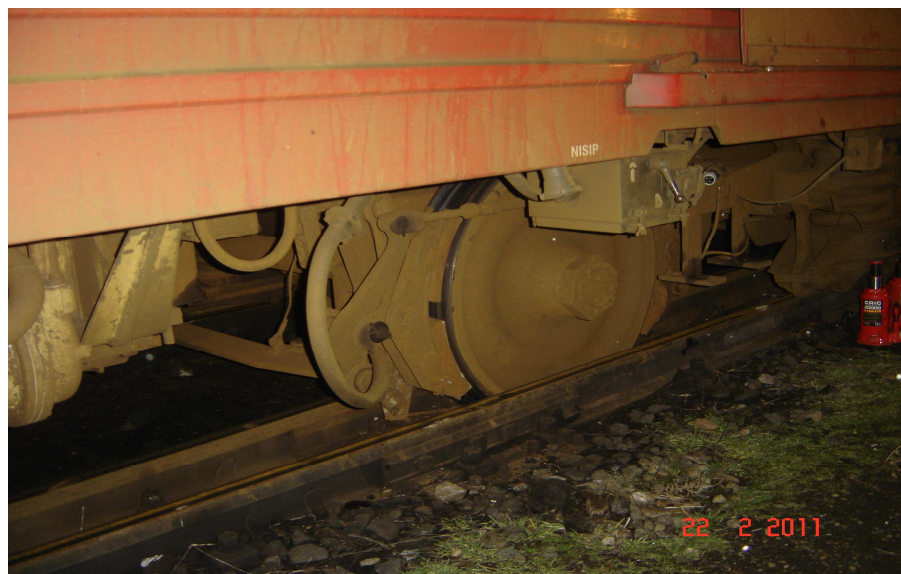
photo no. 2

- the derailment of motorised train no. AMX 4580 of the motor bogie the first in running direction and the first axle of the bogie no.2 , in the area of the switch no.19. (photo 2)

The direct cause of the accident is non bonding the point blade to the stock rail on direct position, which allowed the right wheel of the axle no.1 from the bogie no. 1 (refer to the running direction) to engage in another route than ordered. This was possible by incomplete handling of switch no.19, and non providing it with switch lock.

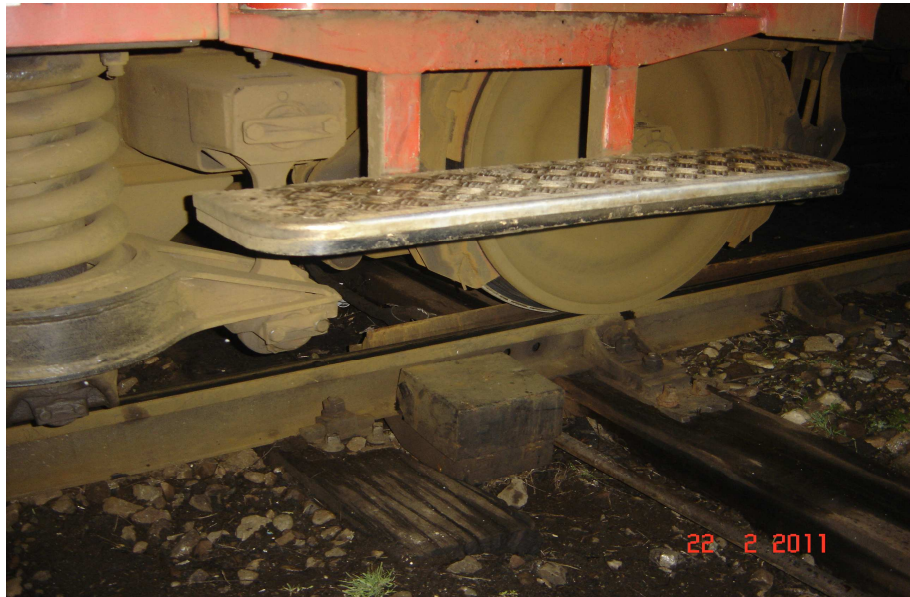
photo no. 3

- between opening switch no.19 and its handling direct position on the deflecting position (photo 3).

The underlying cause of the accident consists in non locking the switch no. 19 which was part of the dispatching route of train no.15812 in contravention with the provisions of art.125 point 2 from Regulation for running trains and hauling railway vehicles no. 005, approved by MTCT no.1816/2005, regarding the receiving / dispatching / passing a train to / from / through the station.

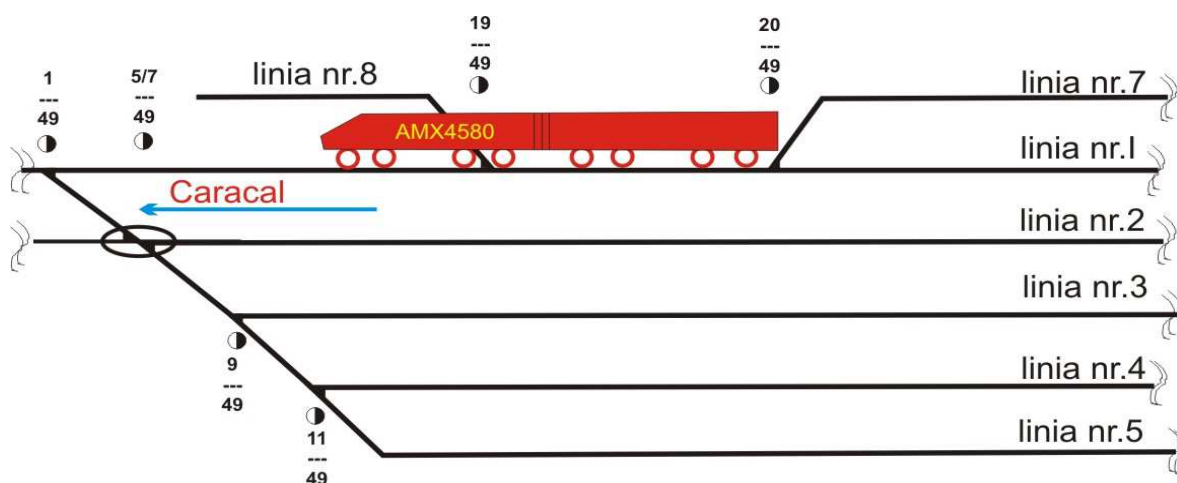
photo no. 4

In railway station Corabia the diesel multiple unit AMX no.4580 is stationed in line no. I until 19:20 in order to compose the train no. 15812 that would run on route Corabia – Caracal. At 19:20, based on the departure signal of the train given by the movement inspector on duty with green light hand lamp pointed at the train and the free indication exit signal group F, the engine driver started to run the train no.15812 , was running about 15m and passing the switch no.19 the motor bogie derailed, the first in running direction and the first axle of the bogie no.2 .

linia nr.8 - remiza de locomotive

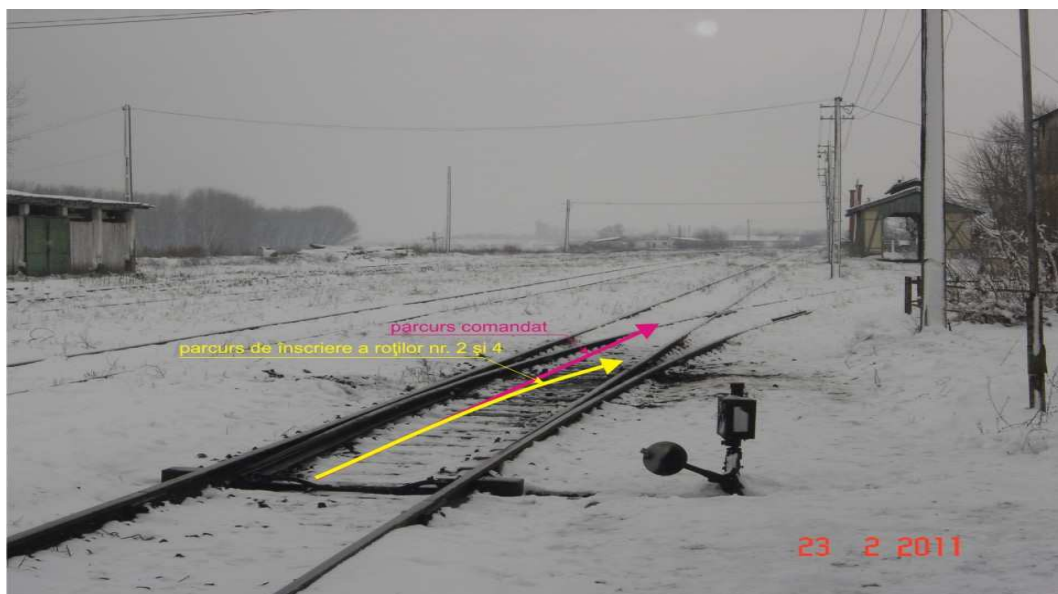
photo no.5

- The wheel no.1 of the axle no.1 run on the ordered route .1 (straight track), and the wheel no.2 dropped between the stock and switch rail traveling itself in another route (diverging track)
- The axle no.2 and axle no.1 of the bogie no.2 travelled on the same route with the axle no.1.

After running an area of approximately 8,80 m, the axle no. 1 from the motor bogie derailed entailing in the derailment process axle no.2 and axle no.1 of the bogie no.2. The diesel multiple unit AMX no.4580 was running in derailed condition an area of approximately 22,20 m. (see photo no.5)
