INVESTIGATING REPORT

of the serious railway accident

occurred on the 16th of October 2013, in the activity of the Branch of the CREIR Cluj, between the railway stations Monor Gledin and Rapa de Jos

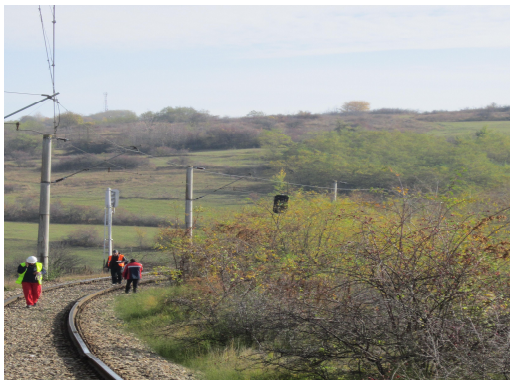
- in the area of the accident occurrence (km 33+003) the track is in curve with a radius of $R=345$ m;
- abundant vegetation on the track embankment, especially on the right side in the running direction, hindering the visibility of the signals;

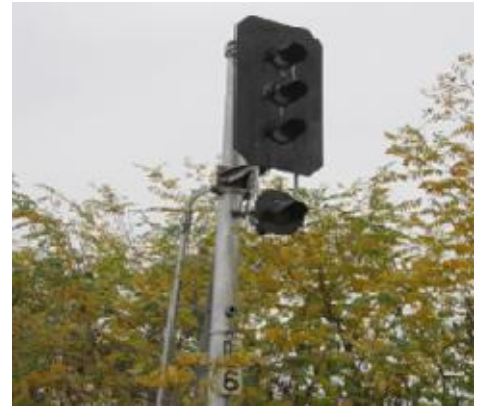
- BL6 signal was off;
- the bulbs red and back-up red were burned;
- the red fire was fed with 11 V tension;
- the yellow bulb was broken;
- the green bulb was intact;
- after the accident occurrence were no damages recorded at the SCB installations.

- the BL 6 signal was off;
- the bulbs red and back-up red were blown;
- the yellow bulb was broken;
- after the derailment occurrence were none damages at the SCB installations.

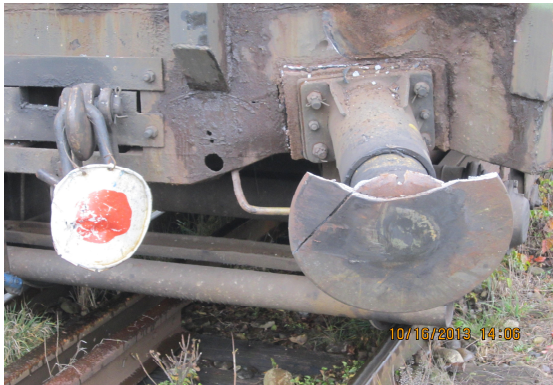
Damages at wagon no. 3535304679-0, the last from the freight train no.50473-2:

- the headstock was deformed in the buffers fixing area;
- approximatively a third from the buffer of the right side in the running direction was broken, the rupture being new.

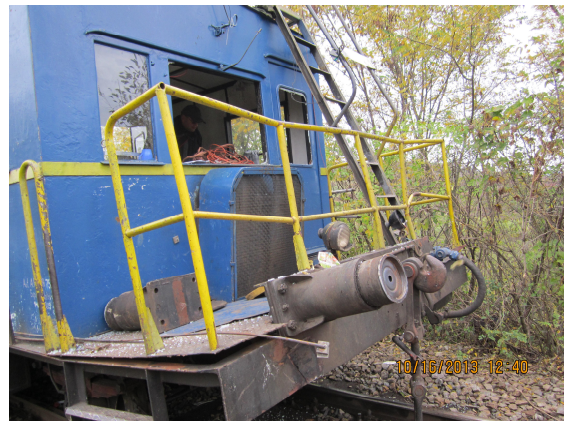
Damages at the tower wagon DP 58

- the front left buffer was fallen;
- the front right buffer gear was damaged;
- the headstock was damaged;
- the front bogie solebar was deformed;
- the front protection hand rail was deformed;
- the front headlamp was broken;
- pantograph was moved and broken from welding;
- the suspension spring from the back had the main leaf broken;
- the diesel engine was moved;
- the driving belts from the compressor and ventilator were broken;
- the front windows were broken;
- journal cross from the gear box to the gearing-down device was torn from coupling;
- the rollers which assured the rotation of the platform were damaged;
- two guiding rollers from the tower were broken;
- the protection net of the tower was dislocated;
- the fastening system of the working bench from the back platform had the screws broken;
- the banks from the rear platform were broken from the fastening system.
