INVESTIGATING REPORT

of the railway accident occurred on the 02nd of February 2013,
in the activity of the Branch of the Regional Center for Railway Operation, Maintenance and
Repairs Timișoara, in the running of the freight train no. 23817 (belonging to the railway
undertaking SNTFM „CFR Marfă” SA), in the railway station Pui, through the derailment of the
last two wagons, due the circular breakage of the wheel's no. 2 web (monobloc wheel) of the wagon
no. 81536655875-8.

Final edition
Bucharest, the 21th of January 2014

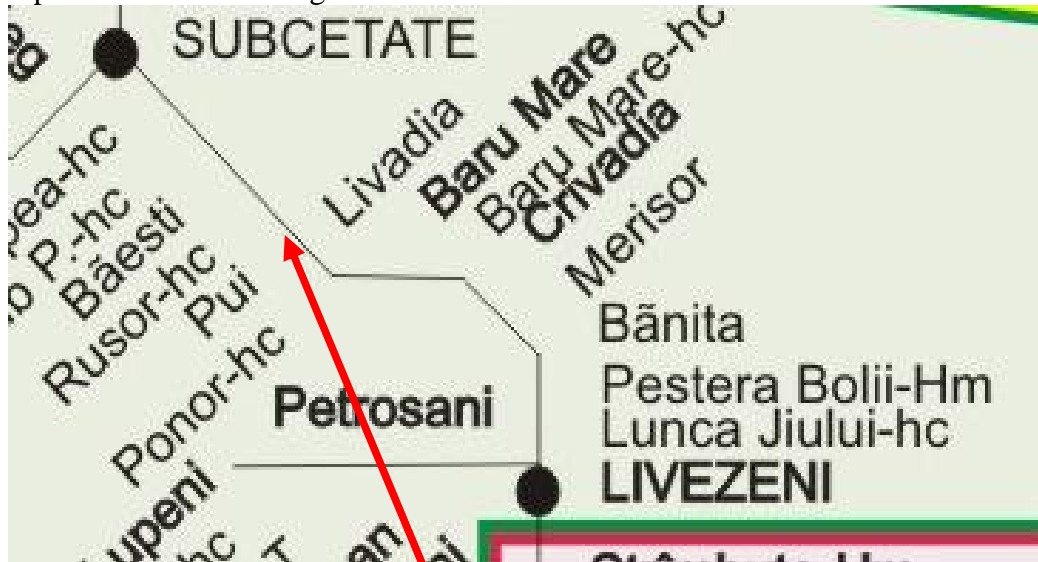
Image no. 1

The accident place is shown in image no. 1

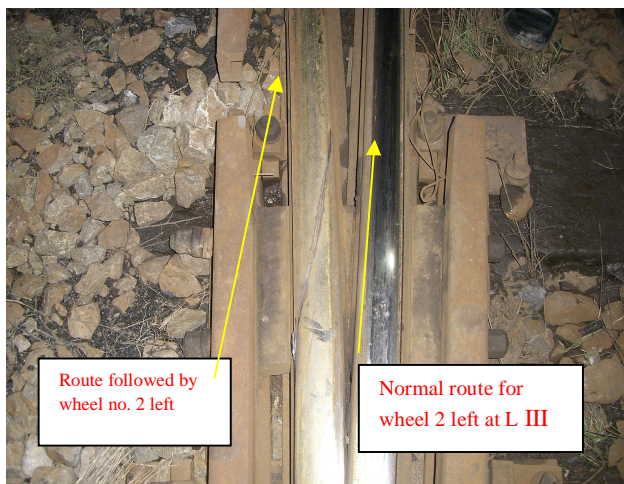
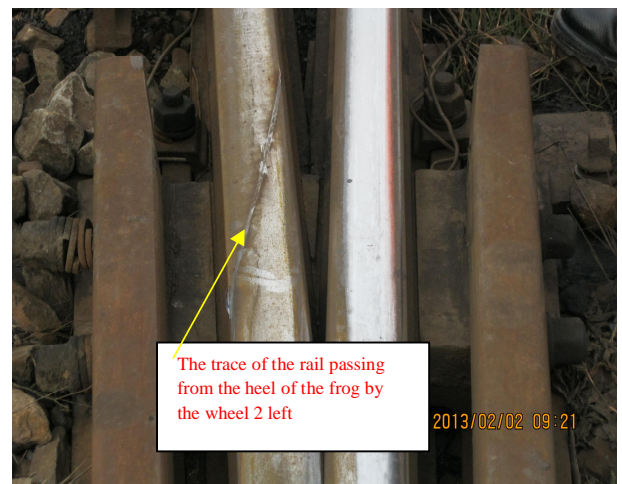
1. at the date of the accident occurrence, the traffic speed on the combined double cross-over S7 – TJD 13/15 – S9 – S11 from line III from the railway station Pui was of 60 km/h for freight trains and 80 km/h for passenger trains;
2. the first trace of derailment was found on the crossing frog from the simple switch no. 7 (type 49 Aa, tg. 1/9, R = 300 m, left deviation) after the running of the flange of the wheel no. 2 from the left side in the running direction afferent to the pair of wheels 1-2 of the bogie no. 1, from wagon no. 81536655875-8, penultimate from the front of the train, on the trench afferent to the deflecting traffic and climbing of the rail from deflection which forms the frog in the right of the last shims at km 44 + 280 (Photo no. 1 and 2);

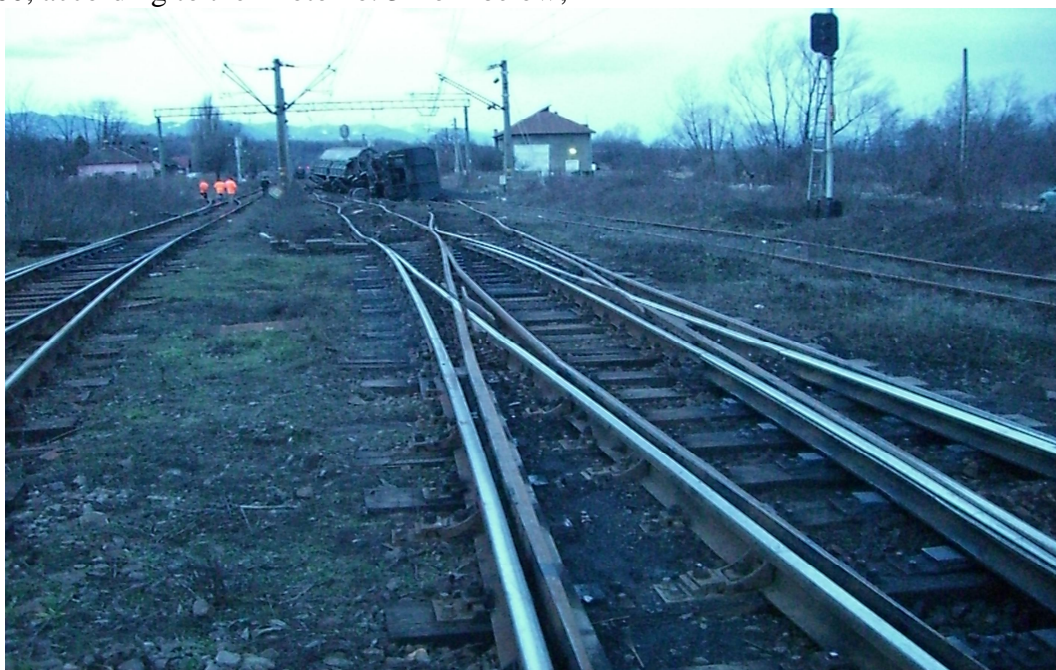
3. after the derailment is running a distance of 120 meters over TJD 13/15 and line III until km 44+160, according to the Photo no. 3 from below;

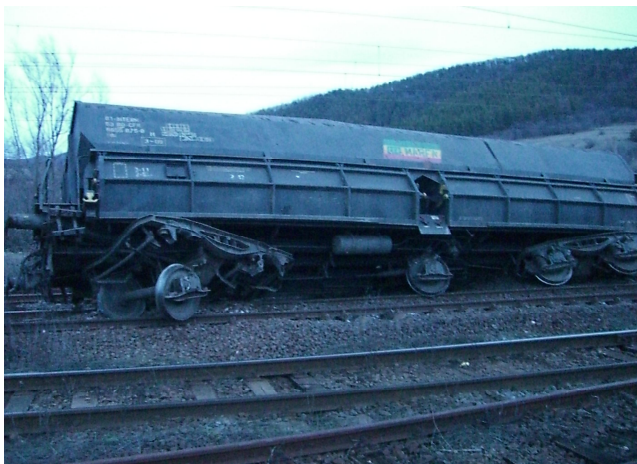
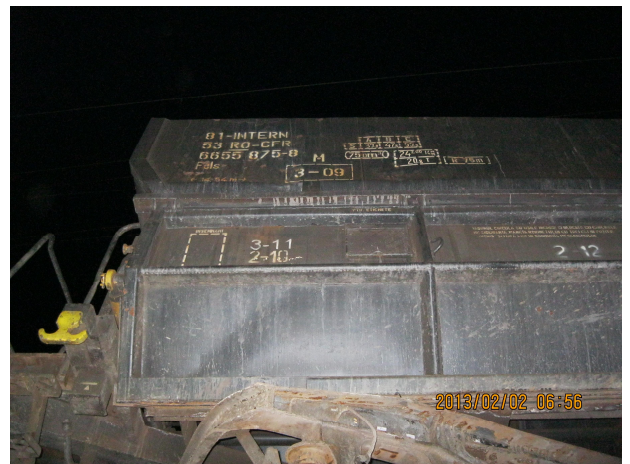
The penultimate wagons from the train, derailed by both bogies, was bended at 45° to the right in the running direction (photos no. 4 – 5)

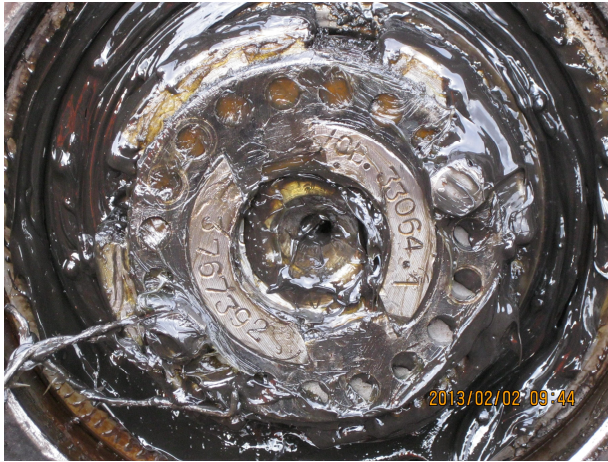
Photo no. 6

- the wheelset with the wheels no. 1-2 had axle with serial no. **3767392**, manufactured by IOB from the cast batch no. 33064.1, the data read from the axle journal, after it was dismantled the cover from the axle box (photo no. 6)

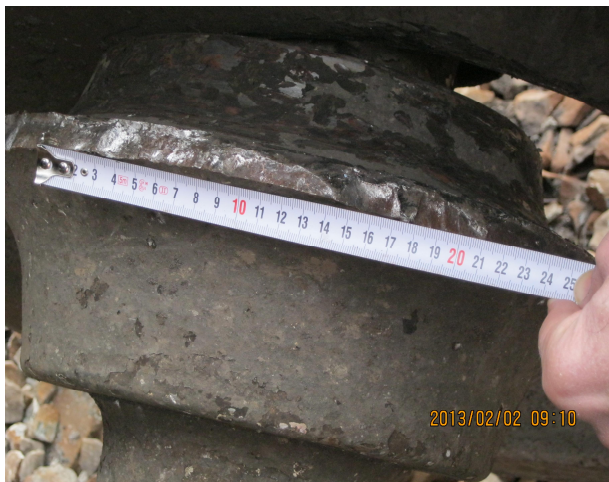
Photo no. 8

- the wheel set with wheels no. 1-2 with wheel no. 2 derailed in the exterior left rail of the track, in the running direction, having the web circular broken on the entire circumference (the length of the circle being of ca. 1200 mm), being deformed to the exterior with an arrow of 20 mm on a length of 220 mm due the impact between this and the wheels boss, occurred after the complete break of the web (photo no. 8 and 9);

1. The monobloc wheel web no. 2, afferent to the axle with wheel no. 1-2 from the first bogie in the running direction of the wagon no. 81536655875-8 had an old circular crack in the transition area with the wheel boss which, due the dynamic loadings at which the wheels was subject in operation, it propagated in section at ca. 60% from the web thickness on the entire circumference.

- the circular breaking of the monobloc wheel's no. 2 web from the first axle of the first bogie from wagon no. 81536655875-8, left part in the running direction, due a circumferential crack occurred in the connection area between the web and the wheel boss, at a distance of ca. 300 mm from the edge of the wheel boss.

The immediate identification of all wagons from the active wagon's stock of SNTFM "CFR Marfă" SA equipped with monobloc wheel made from the cast batch no. 55743 IOB 1991 and those withdrawal from traffic to perform the inspections imposed by the regulations in force at the monobloc wheels to found possibly cracks at the web, rim and wheel boss of those and the applying of the necessary provisions.

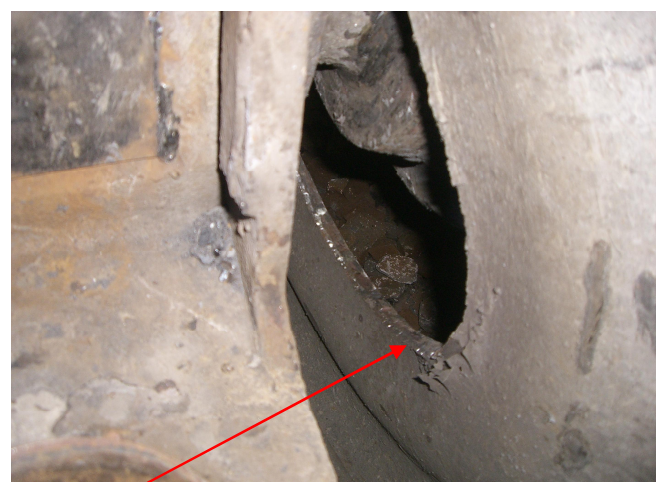
Photo no. 9

old crack

- at the visual inspection in the breaking section was found an **old crack** (Photo no. 9) on the entire circumference with a width of ca. **60% from the web thickness**, the crack was propagating from the interior to the exterior of the wheel. This crack was at a distance of 30 mm in relation with the wheel boss;
- the circular crack was in the connection area of the membrane with the wheel boss (Photo no. 10);
- the wheels no. 1 and 2 don't have transversal movement traces on the axle's body;
- it was found the axle collar, mounted on the axle, this had illegible writings about the axle series and the date of the overhaul;
- the body support from wheel no. 2 broken and at wheel no. 4 being deformed and detached from welding;
- three brake beam deformed;
- the safety steps pieces from the axle with the wheels no. 3-4 are deformed.

- the detachment of the wheel from the wheel boss occurred circular, at the connection of the web with the wheel boss, in section were noticed deformed and beveled traces of some cracks developed repetitive on the whole circumference of the wheel boss, which opened and went through the whole thickness of the web, the last portion of the fragile rupture being constituted from a circular band of ca. 6-7 mm thickness.

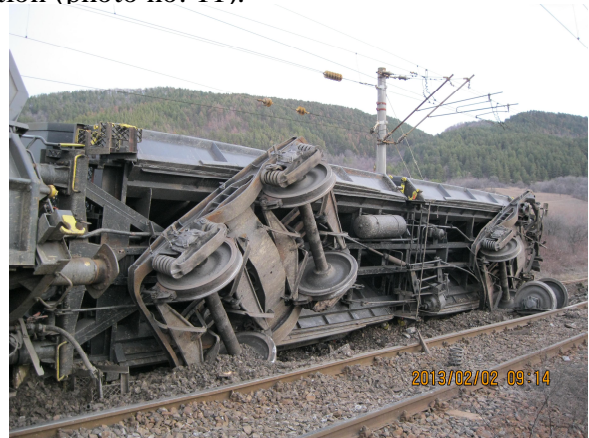
Photo no. 11

- wagon series Fals;
- date of the last overhaul type RP: 25th of June 2012, 6 REV Simeria;
- date of the last repair type DA: 24th of September 2012 – SPC;
- the wagon was the last in the train composition, derailed by both bogies, was overturned on the right side beside the track, in the running direction (photo no. 11).

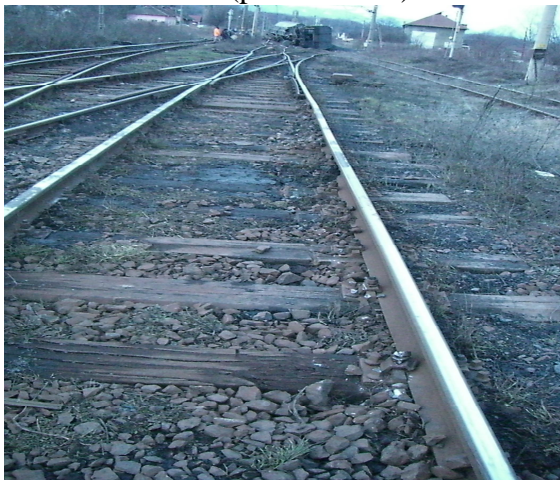
Photo no. 12

4. After the follow of wheel no. 2 on the trench for the deflecting line, wheel no. 1 was guided by the check rail, determined wheel no. 2 to cross over the rail corresponding to the short point of the frog and the fall of wheel no. 2 in the exterior of the rail on the left part in the running direction of the train, time when it is engaged in the derailment and wheel no. 1 in the interior of the rails of the track (photo no. 12).
