INVESTIGATING REPORT

of the railway accident
occurred on the 08th of May 2013, in the activity of the Branch of the Regional Center for Railway
Operation, Maintenance and Repairs Cluj, between the railway stations Fiad and Telciu, at km
21+300

Final edition
28th of March 2014

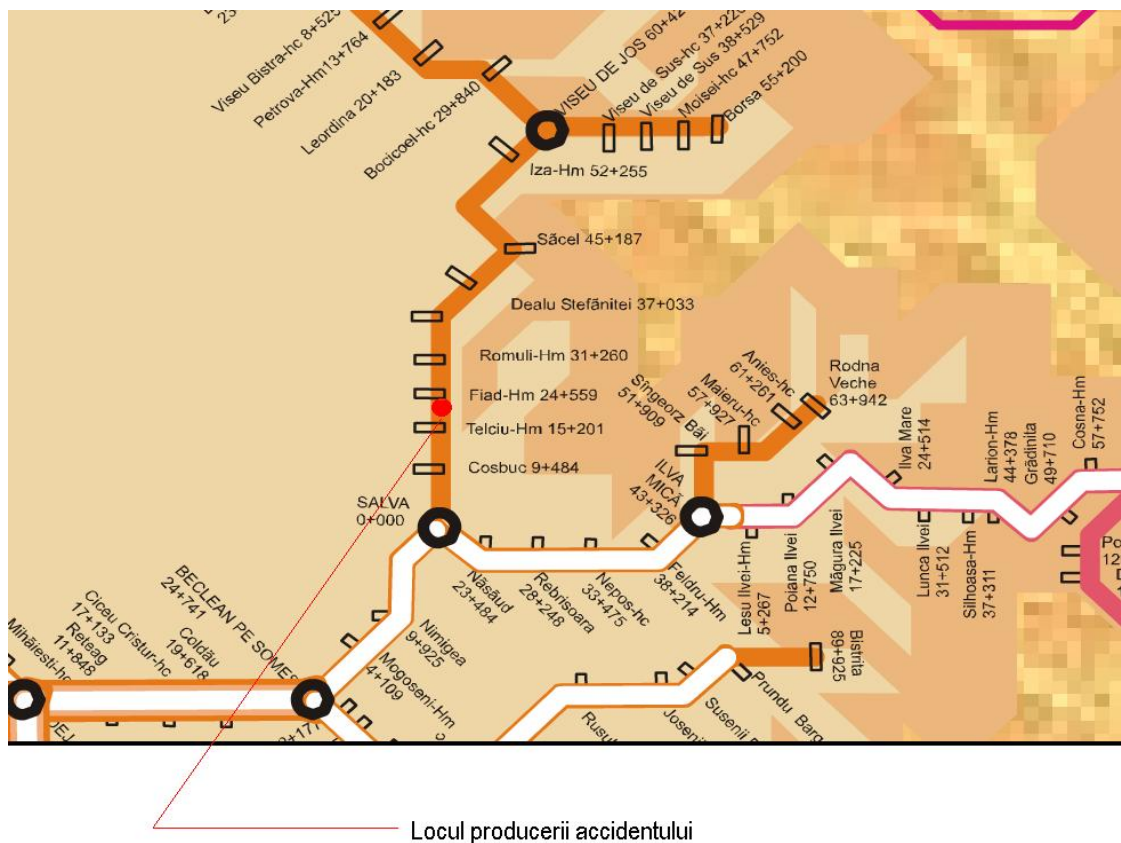
Image no. 1 The place of the accident occurrence

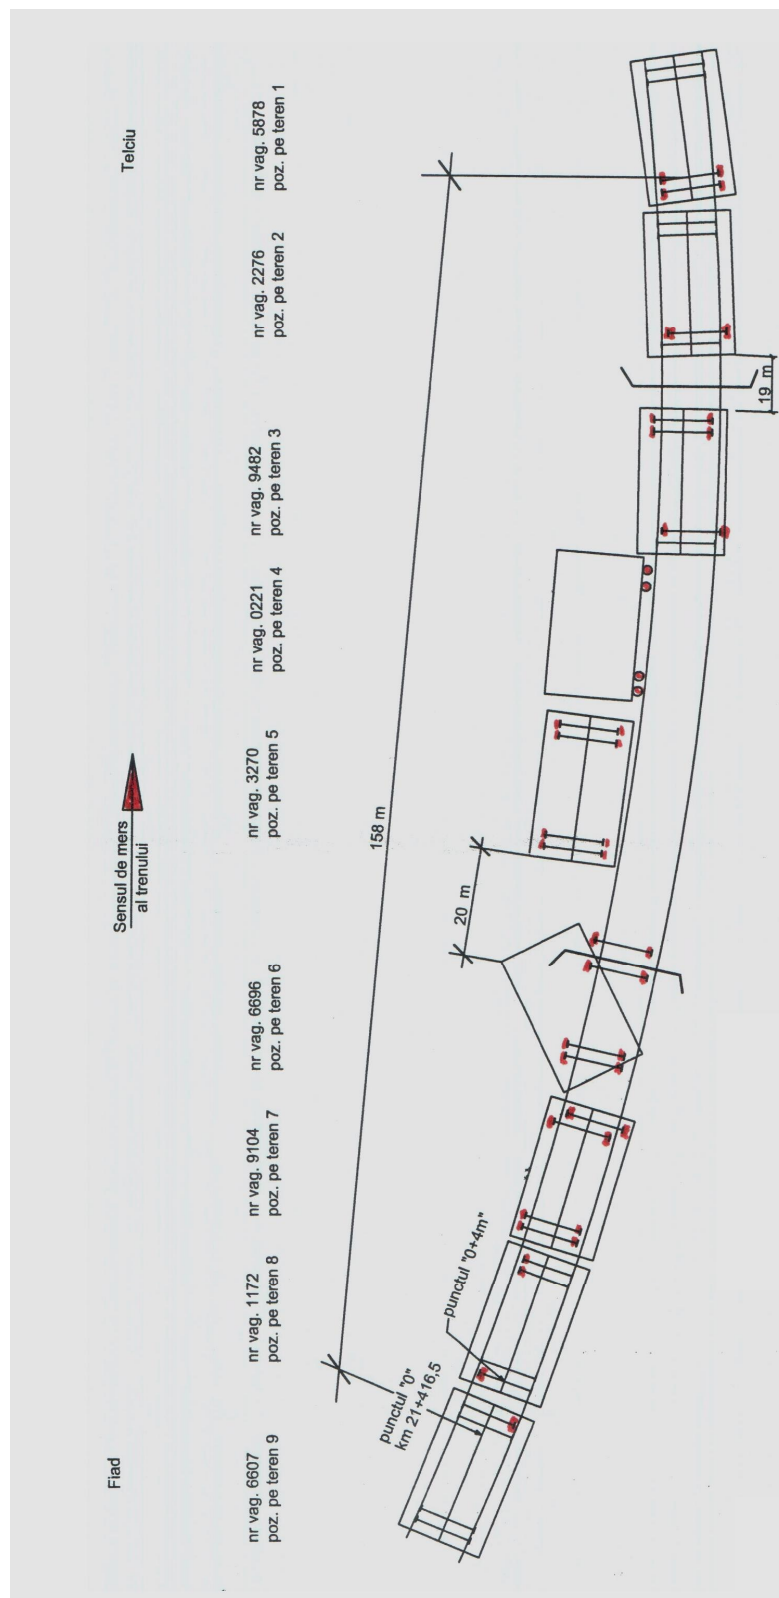
Image no. 2 Positioning on the site of the derailed wagons

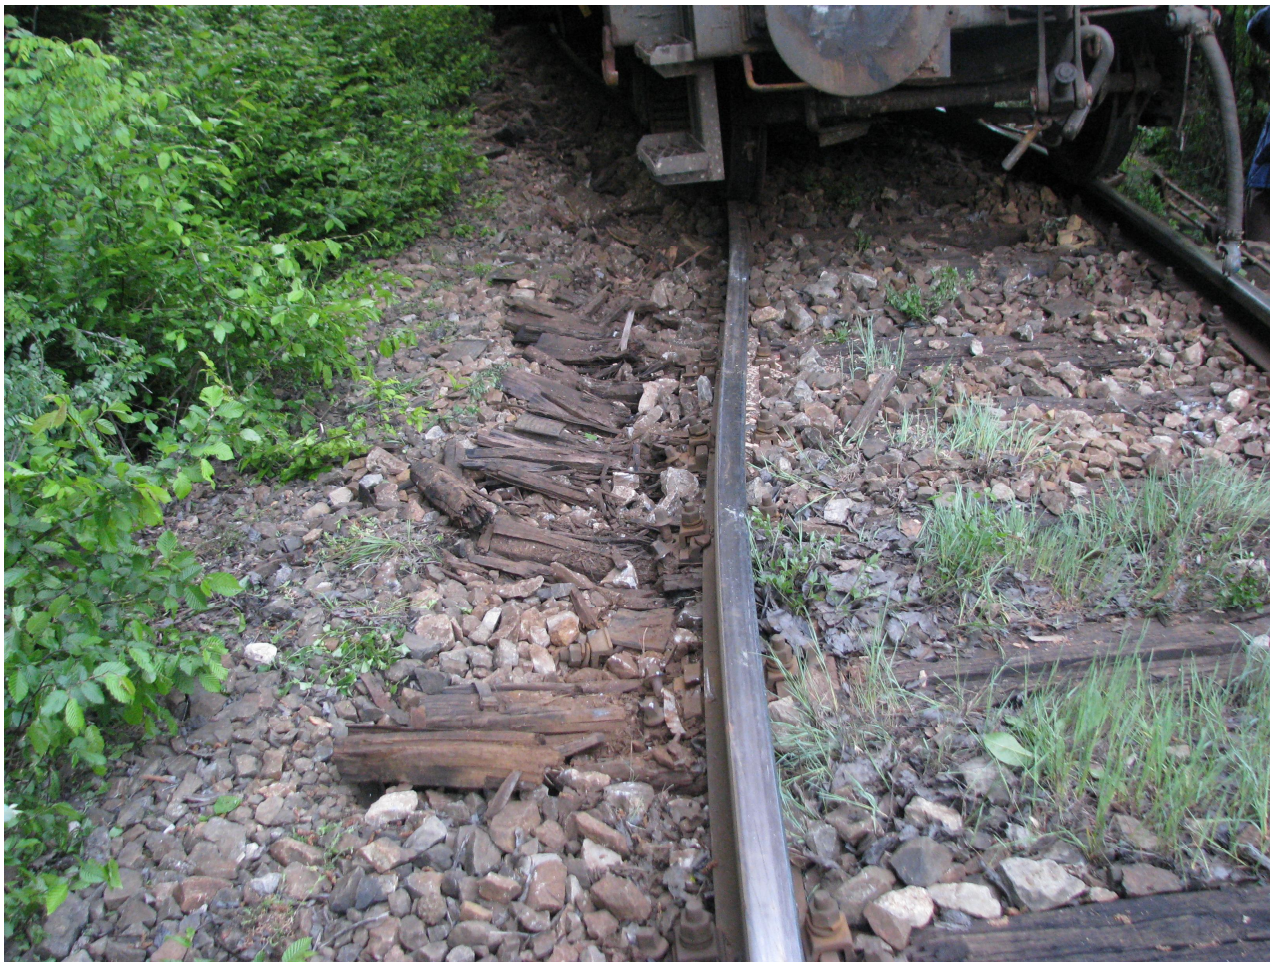
It could not be done the relevant measurements to determinate the geometrical elements of the track on the line between point "0" and to the end toward Fiad of the guideway beam, in the running direction of the train, because of the deformations caused at the line by the wagons in the derailment – **Photo 1**.

Photo no. 3 Deformations caused on the line by the wagons during the derailment

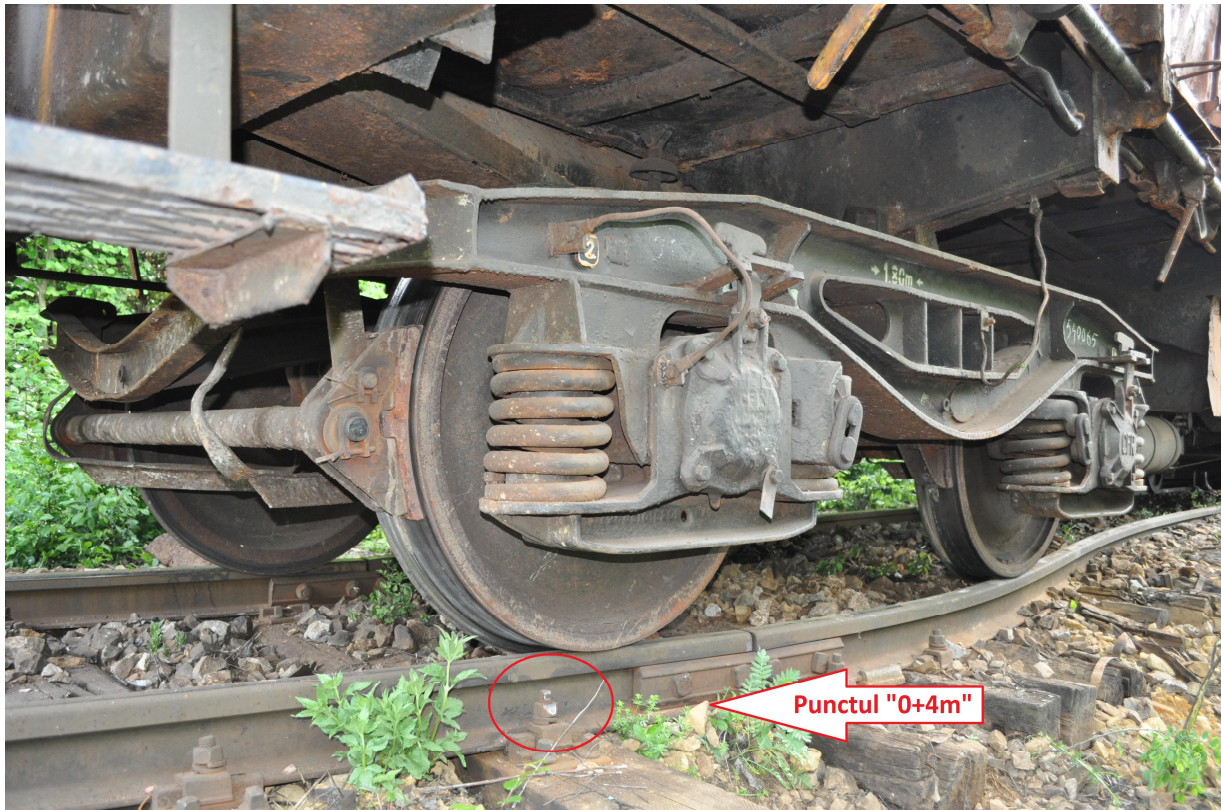
Analyzing the evidences from the site it was found that at the end of the bridge toward the railway station Fiad it was identified on the sleepers, fastening material and embankment traces of derailment to the exterior of the curve, continuing to the railway station Fiad to a distance of 8 sleepers from the point "0". The mentioned derailment trace to the exterior, situated to a distance of 8 sleepers from point "0", was identified in the front of the last axle of the 8th derailed wagon (1172) and is presented in the form of a hitting trace on a vertical bolt.

Photo no. 4 The derailment trace called Point "0+4m"

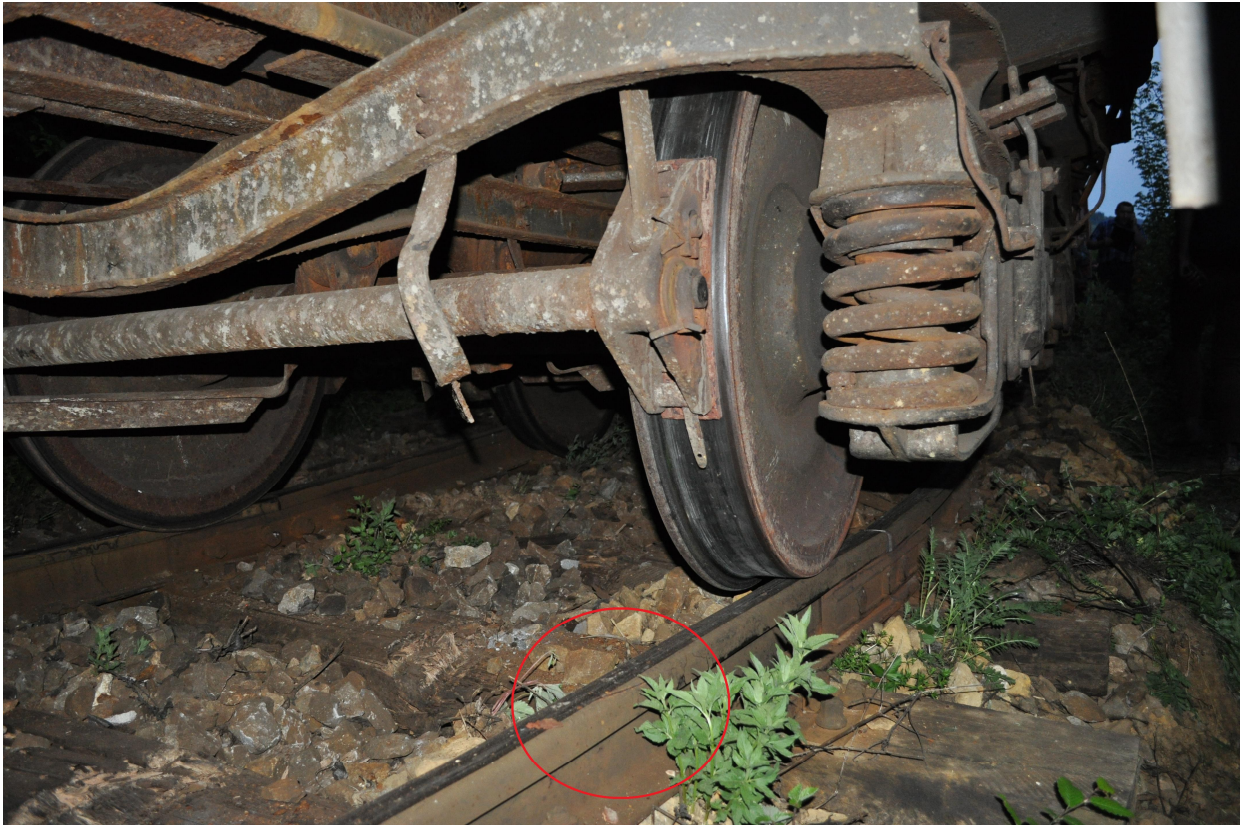
In the area of the point "0+4m" were identified a number 3 derailment traces on the right side in the running direction (the falling of the wheel from the head of the rail), presented in **Photo no. 5** and **Photo no. 6**.

Photo no. 5 - A derailment trace on the right side

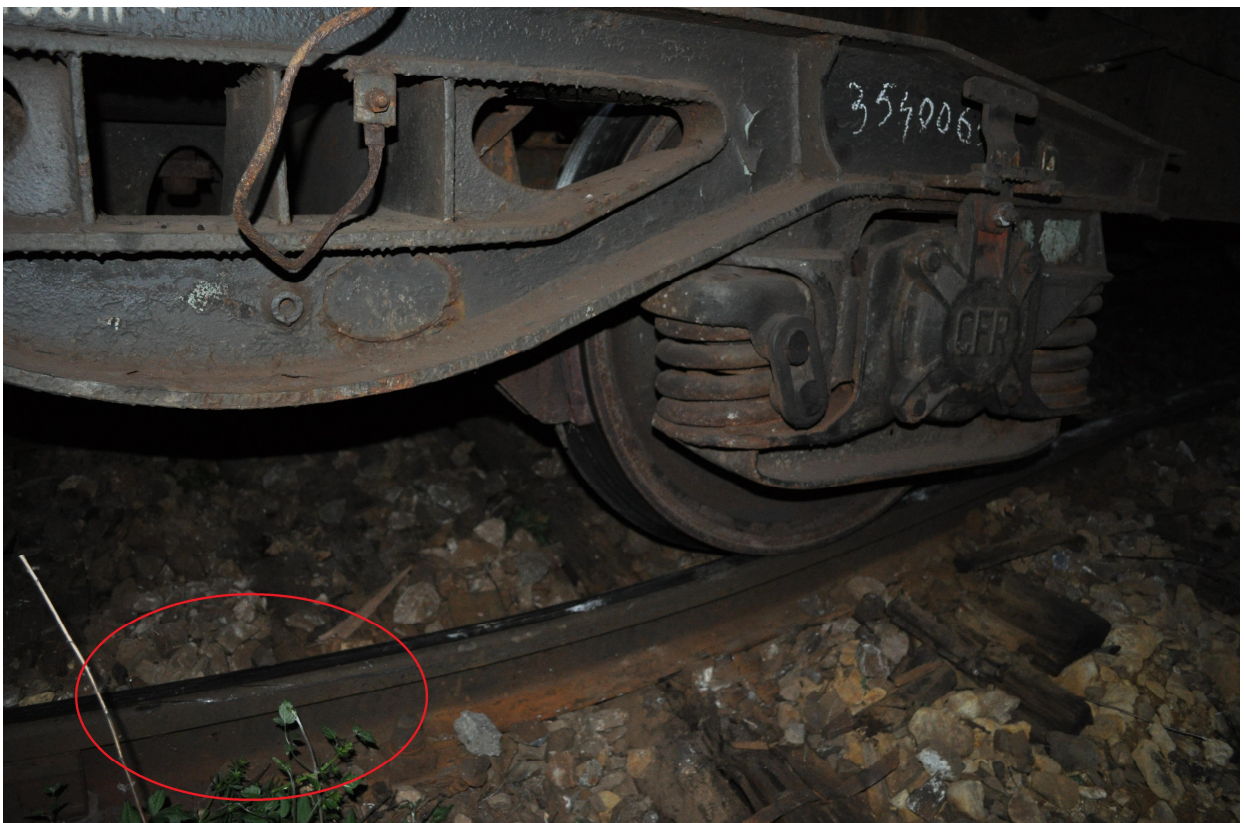
Photo no. 6 - 2 derailment traces on the right side

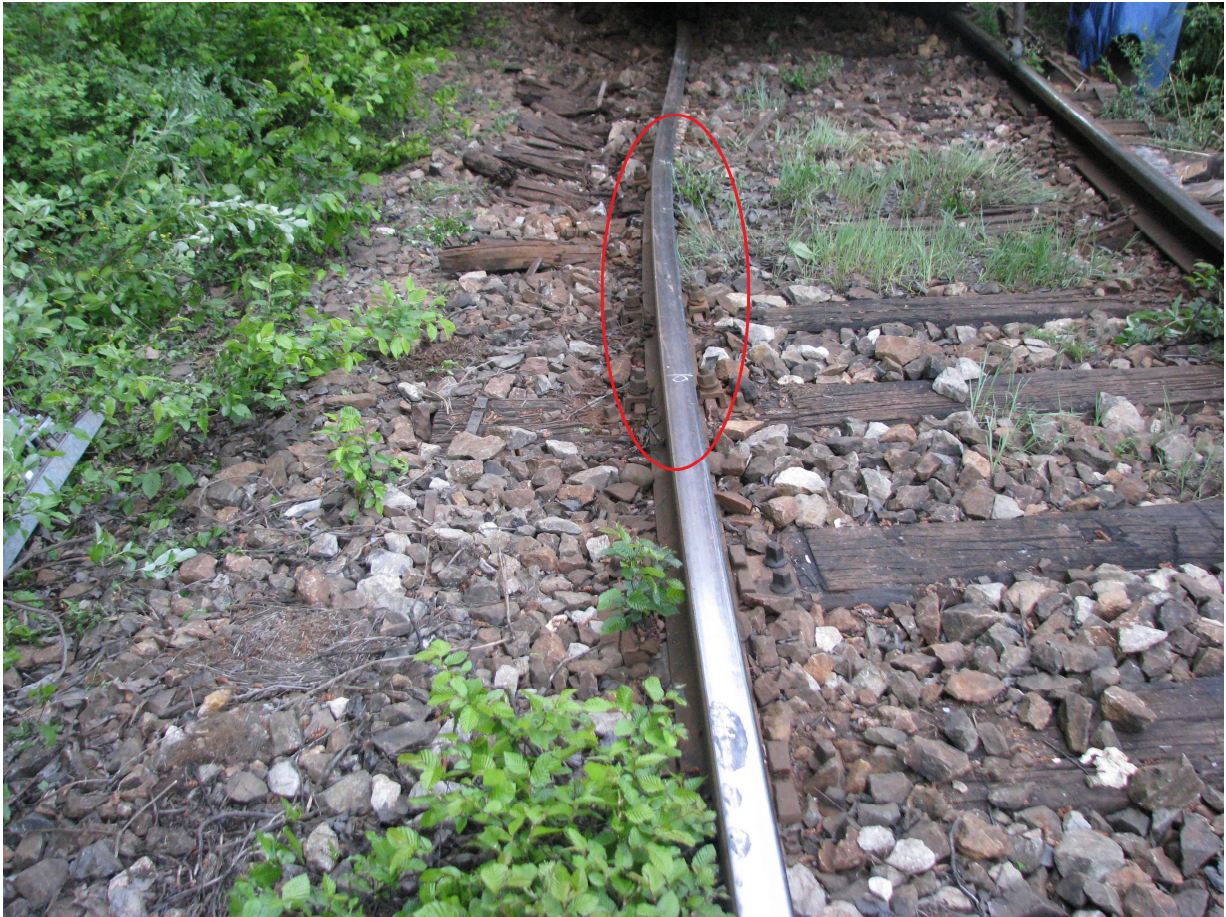
Photo no. 7 – The four derailment traces from the left part

Also it was identified in the area of point “0” a number of 4 derailment traces on the left part in the running direction (the falling of the wheel from the head of the rail) **Photo no. 7**.

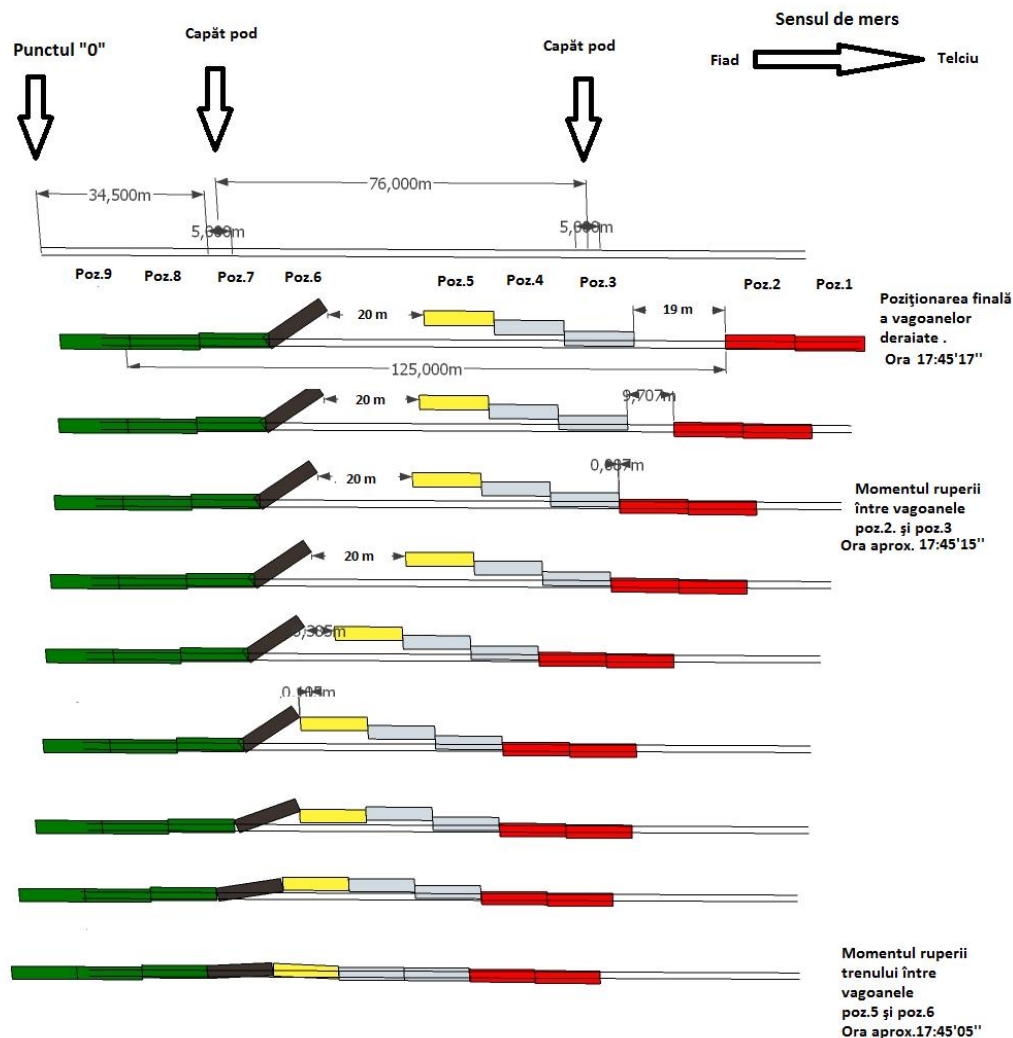
To establish the succession of the train breakings after the train derailment were analyzed recordings of the locomotives and the clues found at the wagons and infrastructure. With this in mind it was concluded that the succession of 2 train breakings between the derailed wagons occurred first between the wagons 5 and the 6 and later between position 2 and position 3. Graphical representation of these train breakings is presented in Figure. 3.

Image no. 8 The succession of the train breakings with the representation of the 9 derailed wagons

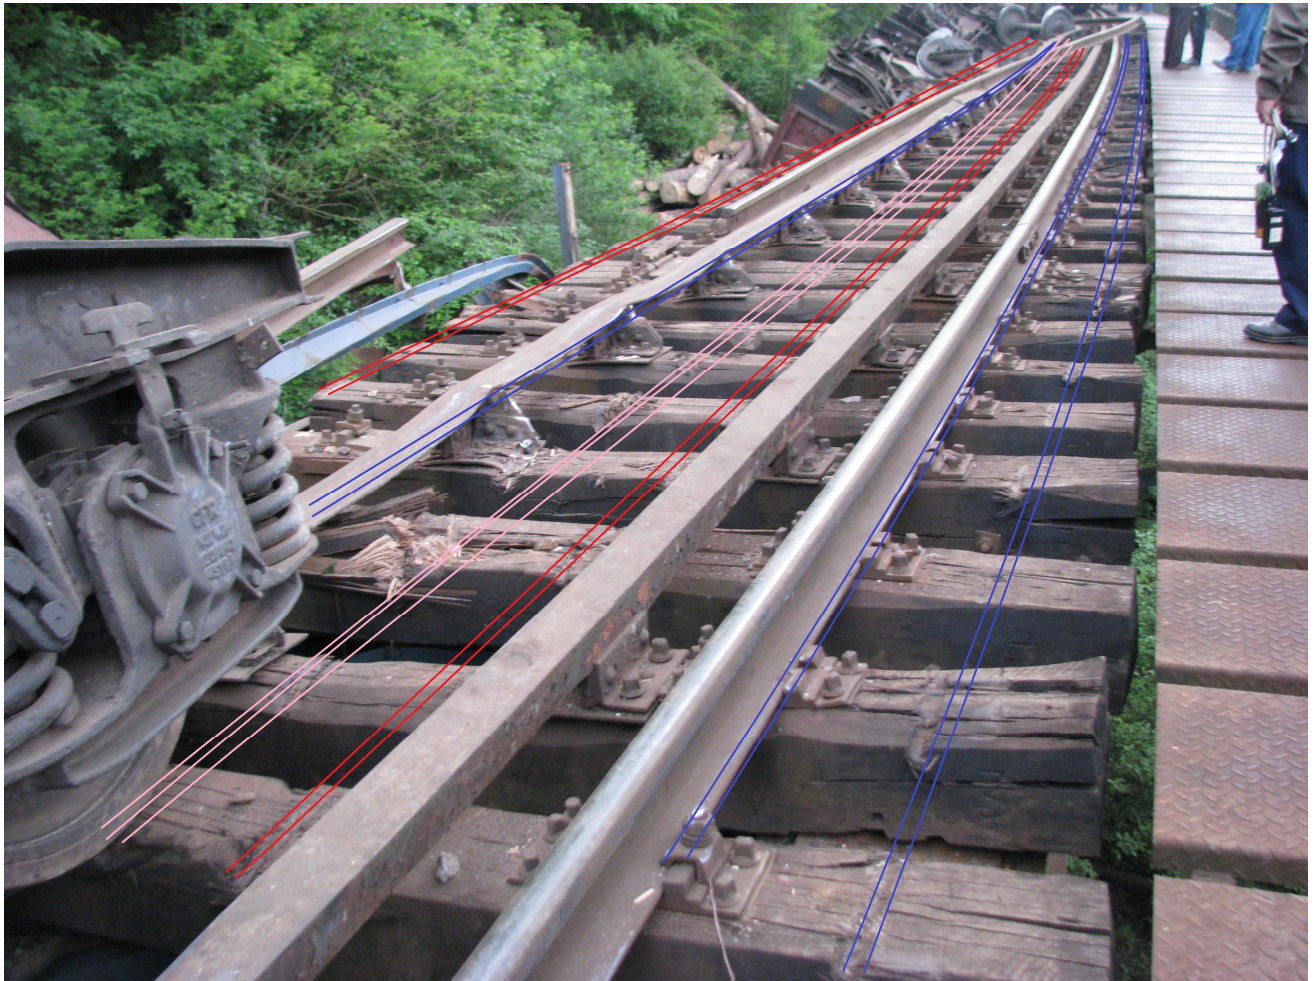
On the bridge passing of the derailed wagons, those let more traces sets printed on the sleepers, on the fastening elements of type K and on the check rails shown on Photo no. 9.

Photo no. 9 The traces left on the bridge by the derailed wagons
