ROMANIAN RAILWAY INVESTIGATING BODY

INVESTIGATING REPORT

of the railway accident occurred on 07.04.2013 on the Branch
of the Regional Center for Operation, Maintenance and Repairs Timișoara,
between the railway stations Baru Mare and Pui.

Final Edition
18.07.2013

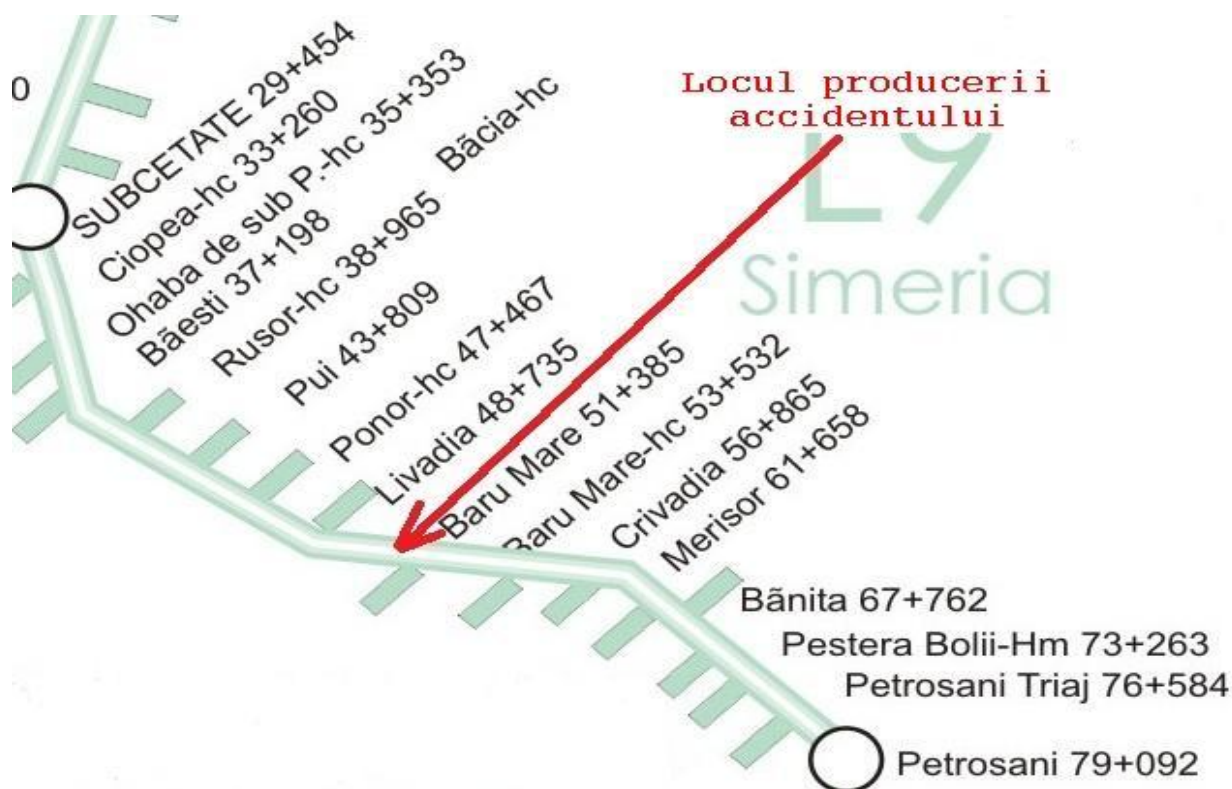
Figure no.1

The place where the accident took place

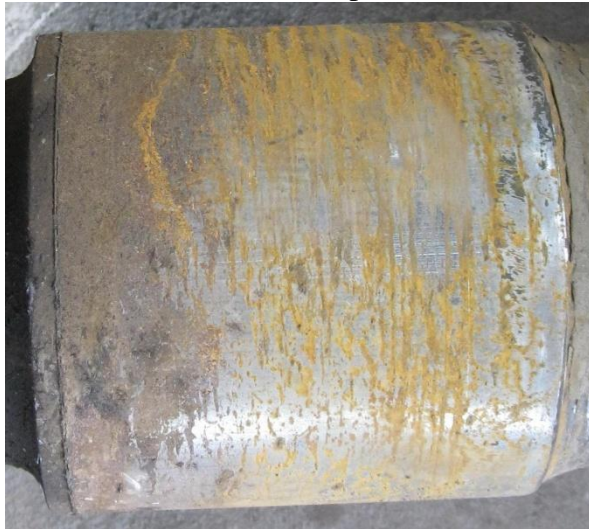
photo no.2

- Wheel 5 (the left wheel in the running direction)
 - complete displaced and axially movable towards middle of the axle;
 - wheel seat of the axle next to the axle box presents rust in depth in points on a section with irregular shape with a surface of approximately 500 mm²(photo.no.2);

- b) on the wheel seat of the axle corresponding the wheel no.5, in the side next to the axle box, profound rust points on a section with irregular shape with a surface of approximately 500 mm².

Appearance in depth of rust on the entire circumference of the axle pressing sections on a variable width between 22 – 38 mm respectively rust points in depth on a portion with an irregular shape with a surface of almost 500 mm², by damaging the tightening force of the wheel hub on the wheel seat on the axle caused by a non-conformity in the process of assembling the wheel-set.

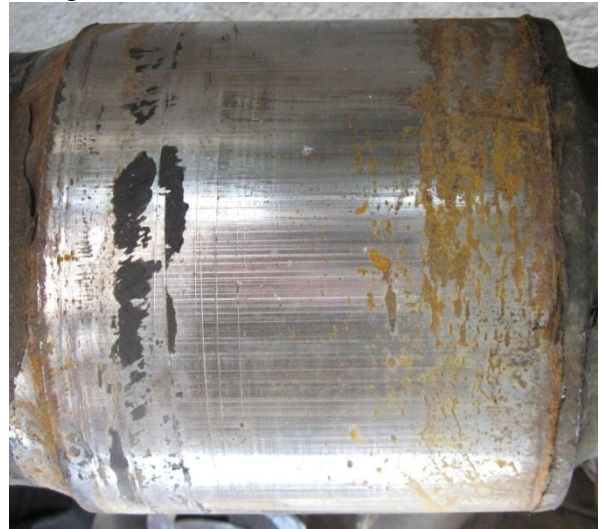
photo no.3

- wheel seat of the axle next to the axle box presents profound rust , over the entire circumference on a variable width between 22 – 38 mm. The area has a rugged appearance with damage of the surface and at the same time the tightening (photo no.3);

- at axle 4-5 it is noticed:
 - a) on the wheel seat of the axle corresponding the wheel no.4, the existence of a section with rust, old, in depth, over the entire circumference on a variable width between 22 – 38 mm, area having rust appearance;
