INVESTIGATING REPORT

of the railway accident occurred on 07.04.2013 on the Branch
of the Regional Center for Operation, Maintenance and Repairs Timișoara,
between the railway stations Baru Mare and Pui.

Final Edition
18.07.2013

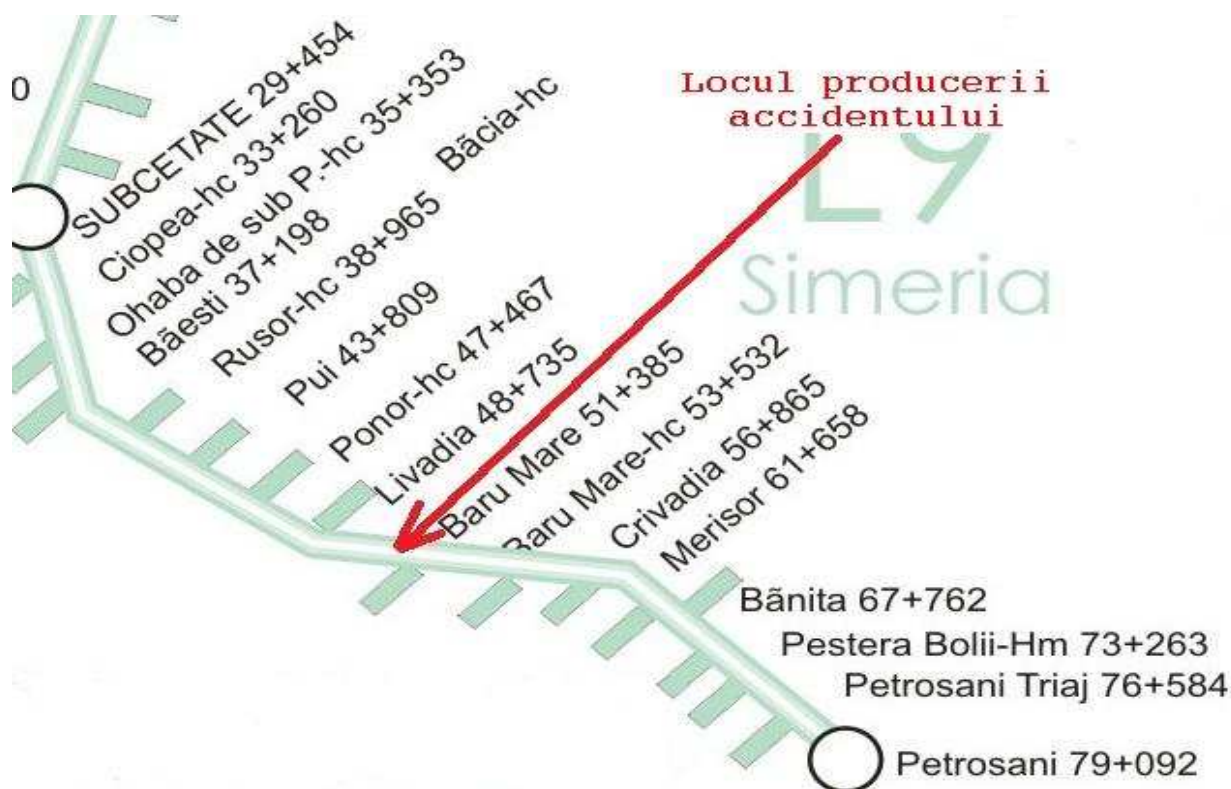
Figure no.1

The place where the accident took place

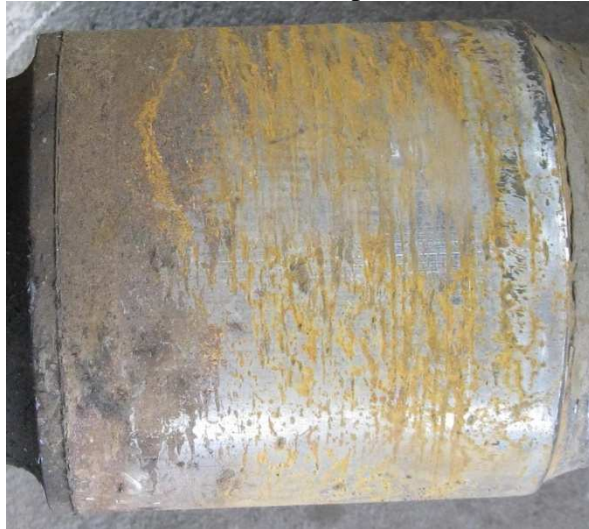
photo no.2

- Wheel 5 (the left wheel in the running direction)
 - complete displaced and axially movable towards middle of the axle;
 - wheel seat of the axle next to the axle box presents rust in depth in points on a section with irregular shape with a surface of approximately 500 mm²(photo.no.2);

- b) on the wheel seat of the axle corresponding the wheel no.5, in the side next to the axle box, profound rust points on a section with irregular shape with a surface of approximately 500 mm².

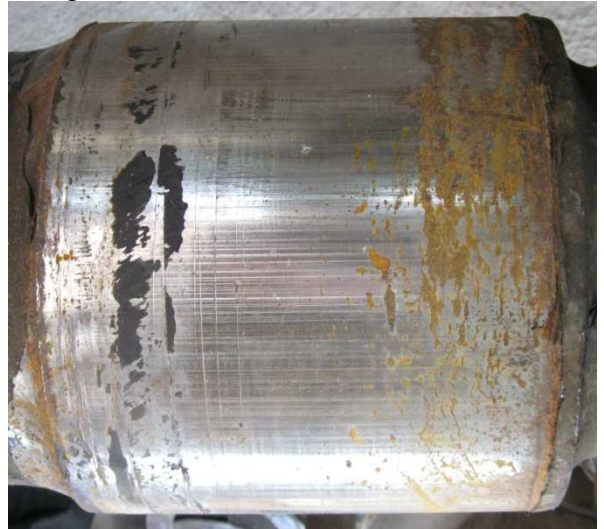
photo no.3

- wheel seat of the axle next to the axle box presents profound rust , over the entire circumference on a variable width between 22 – 38 mm. The area has a rugged appearance with damage of the surface and at the same time the tightening (photo no.3);

- at axle 4-5 it is noticed:
 - a) on the wheel seat of the axle corresponding the wheel no.4, the existence of a section with rust, old, in depth, over the entire circumference on a variable width between 22 – 38 mm, area having rust appearance;
