INTERIM STATEMENT

about the railway accident happened on 19th February 2025 in the railway station Mihăești

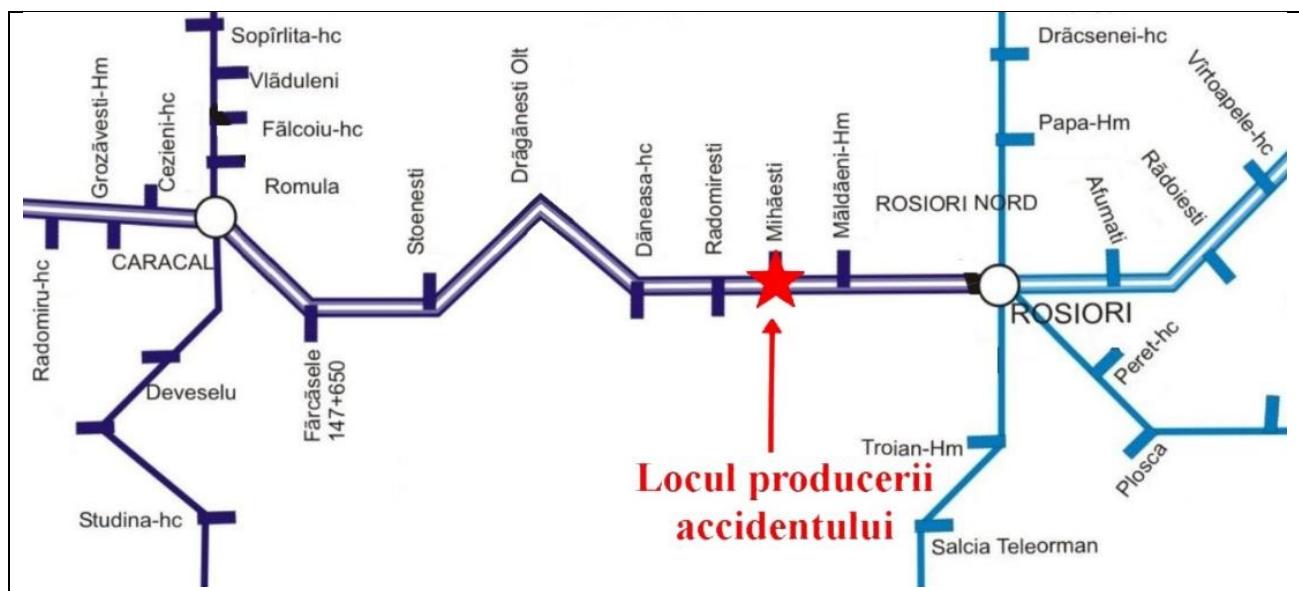
On 19th February 2025, at about 10:42 o'clock, in the railway county Craiova, on the track section Roșiori Nord – Caracal (electrified double-track line), at the exit of the railway station Mihăești, on track I (at the Y end – the area of turnouts no.10–12), the derailment of four wagons from the composition of freight train no.57306, got by the railway undertaking Rail Cargo Carrier România SRL, occurred. As a consequence of the derailment, the 17th wagon of this train collided with locomotive ES 008, which was hauling freight train no.58572, running in the opposite direction, on track II.

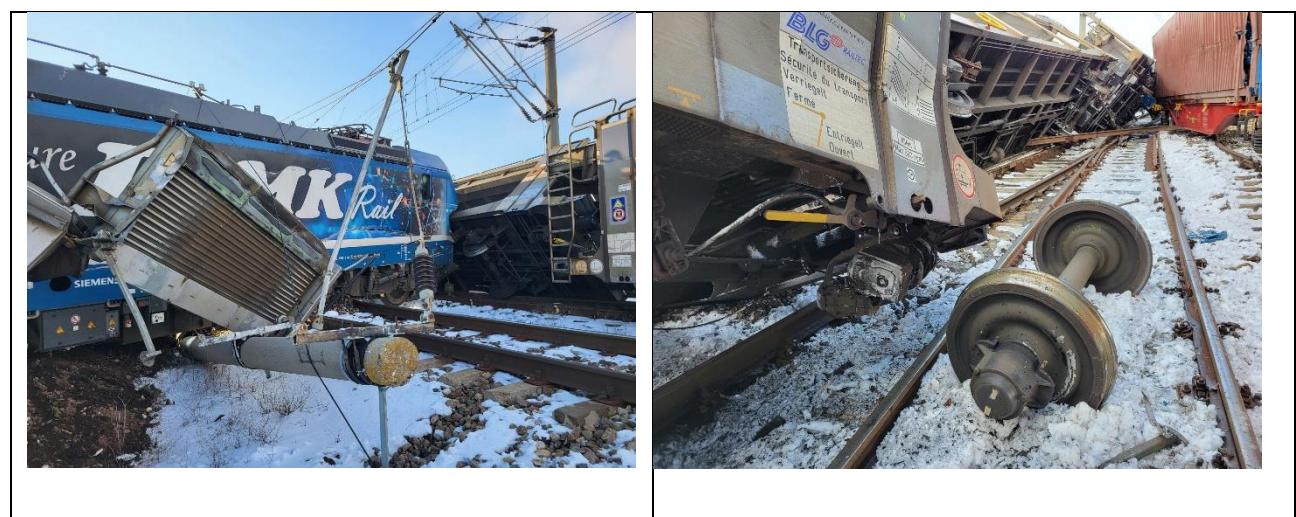
As a consequence of the accident, four concrete poles supporting the overhead contact line (no.75, 76, 81 and 83) were affected, and the overhead contact line between poles no. 77 and no.85, as well as between no.74 and no.82, was broken and fell to the ground.
