AGENȚIA DE INVESTIGARE FERROVIARĂ ROMÂNĂ - AGIFER

INVESTIGATION REPORT

for the incident happened on the 17th of February 2015
in the branch of the Railway County Craiova,
in the railway station Drăgășani, in the running of the passenger train Regio no.2455,
consisting in the breakage of the driving axle from the diesel multiple unit AM 917

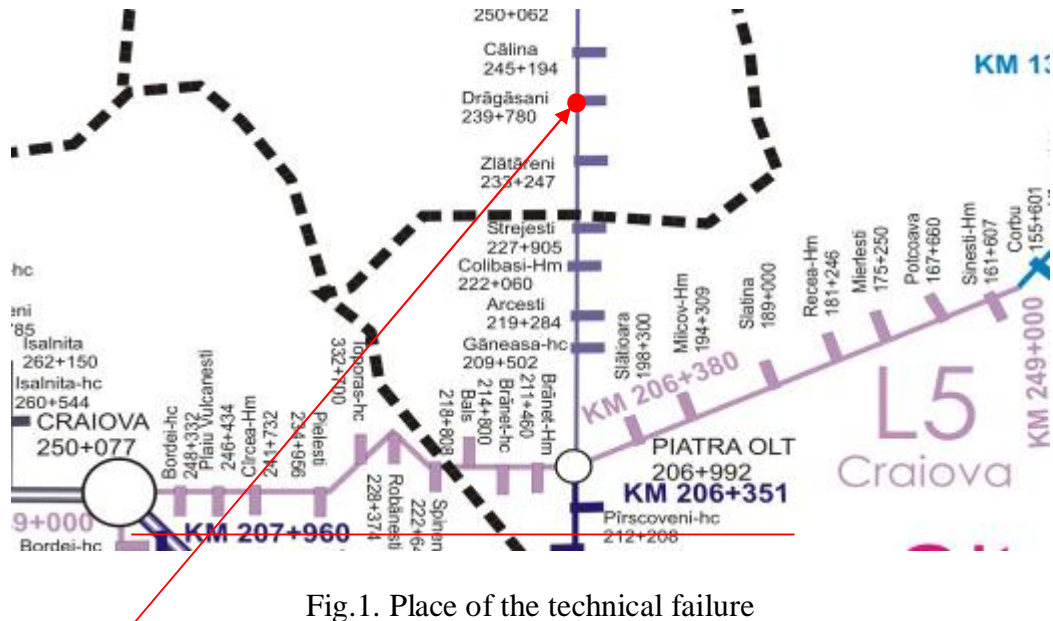
Fig.1. Place of the technical failure

On the 17th of February 2015, at about 11:10 o'clock, in the branch of the Railway County Craiova, in the running of the passenger train Regio no.2455 (belonging to the railway passenger undertaking SNTFC „CFR Călători” SA), in the railway station Drăgășani, km 240+600, the axle journal of the axle no. 1 broke (left side in the running direction) from the motorised train AM 917, between the switch no.2 and the entry semaphore signal Y of this station.

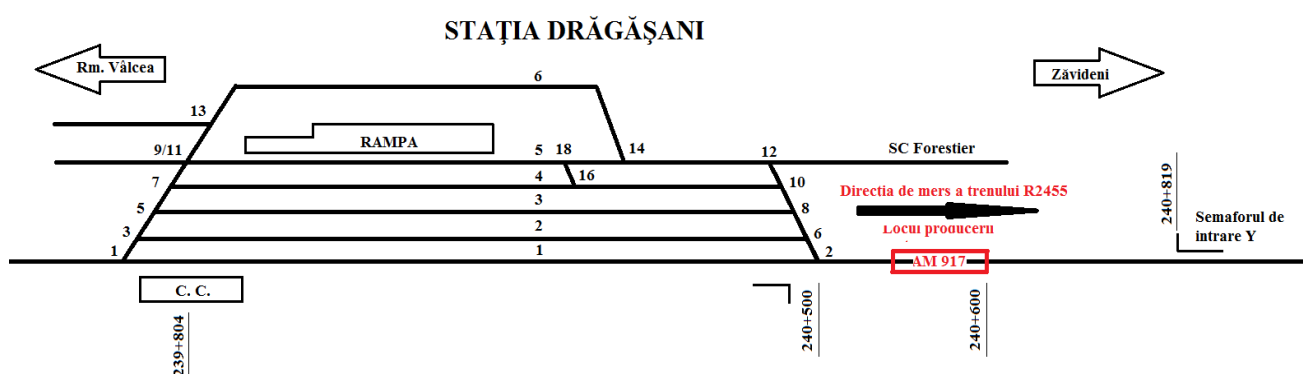
Picture 2. Incident site in the railway station Drăgășani

At 11:05 the passenger train Regio no.2455 consisting in the DMU AM 917 was dispatched from the railway station Drăgășani, line no.2, to Zăvideni. After the train left the railway station Drăgășani, between the switch no.2 and the entry semaphore Y of the railway station Drăgășani, the journal of the driving axle broke, first in the running direction, picture 2.

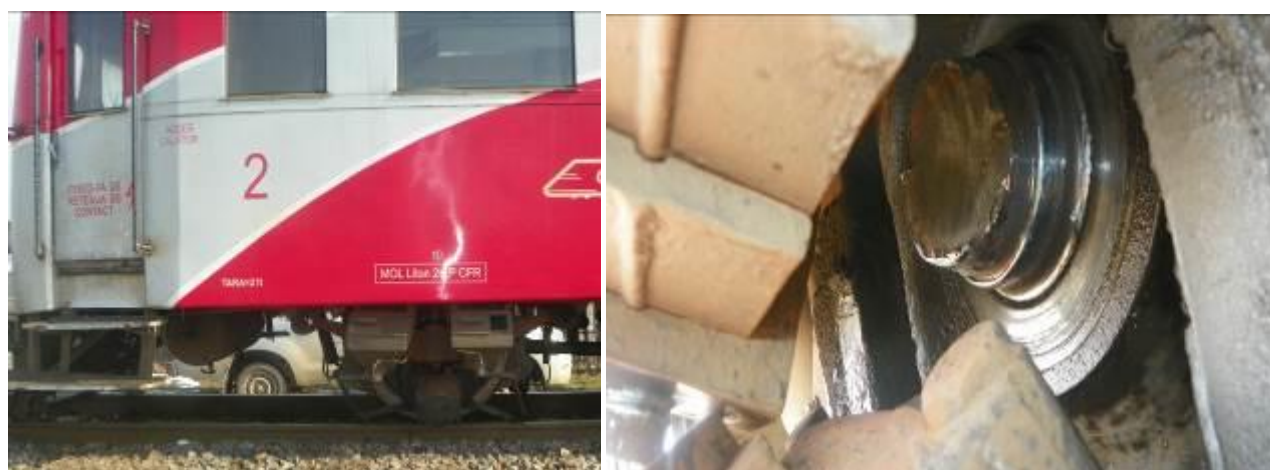
At the visual inspection of the driving axle, one found out the breakage of the axle journal on left side of the running direction, respectively from the short part of the axle – picture no.1.

Picture no.1 – breakage of the axle journal on the left side in the running direction, respectively from the short part of the driving axle

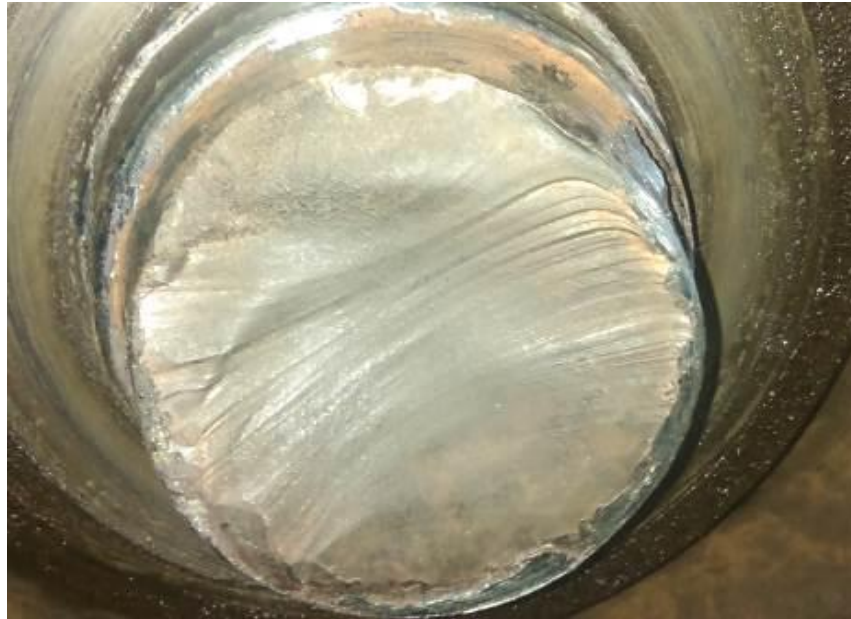
- the gear oil from the quill drive had a suitable appearance, without scrapings traces;
- the axle has breakage 100%, new in the area of the journal left side running direction (picture no.2);

Picture no.2 –

section of the axle journal

breakage

- the breakage surface (fracture from the detached journal) is preponderant like a fatigue breakage (progressively). This aspect is typical for the case where the breakage started through high stresses and ended through low stresses. On the inferior part one can observe the end breakage area, maybe with material removal, that was settled and burnished during the repeated contacts. On the flat perimeter of the section one can observe multiple radial scratch marks” (small edges) , that are the start of the breakage from the exterior surface, under the stress stretching – compression of the axle. The under-stressing periods (during the crack opening) one can observe on the fatigue breakage some “hardening lines”. The shape of those lines shows the stress to which the axle was subject (stretching-compression, above mentioned). The front line consisting in the partial overlapping of two start areas of the breakage, started with concave aspect in relation to the initial centre. As the breakage progressed, the line became horizontal, than became corrugated to its ends and transformed in the convex line to the end of breakage, it showing a stress to rotary bending of the axle. On the perimeter of the breakage surface

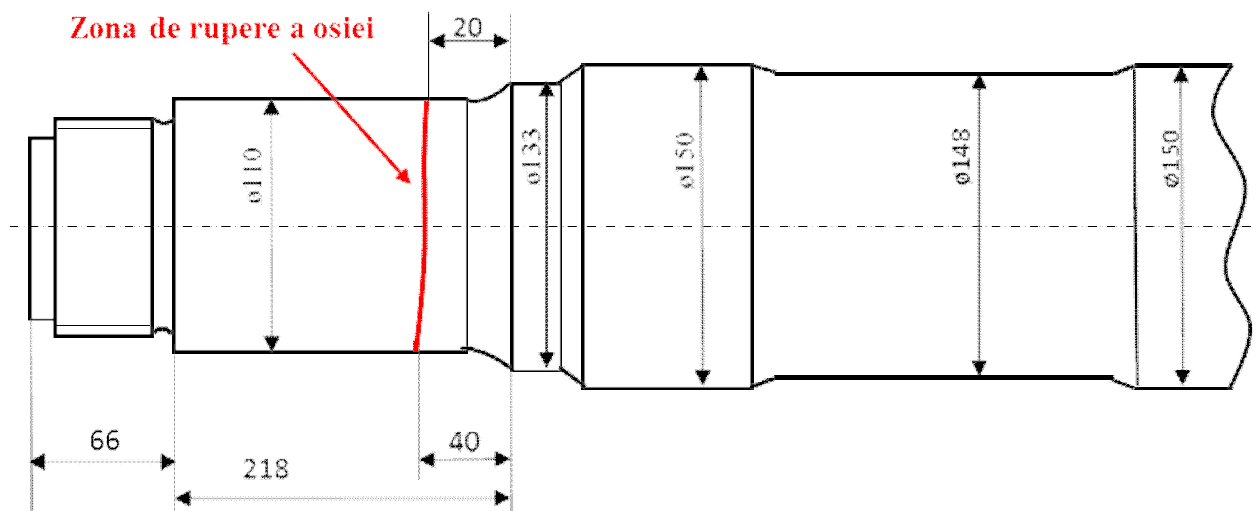
Picture 3 Breakage area

- the brakage section is slightly inclined and has the next space quotas:
 - maximum distance as against the wheel body 70 mm;
 - minimum distance as against the wheel body 50 mm;
 - maximum distance between the breakage area and the connection area of the axle journal and the the sealing ring 40 mm;
 - minimum distance between the breakage area and the connection area between the axle journal and the sealing area 20 mm.

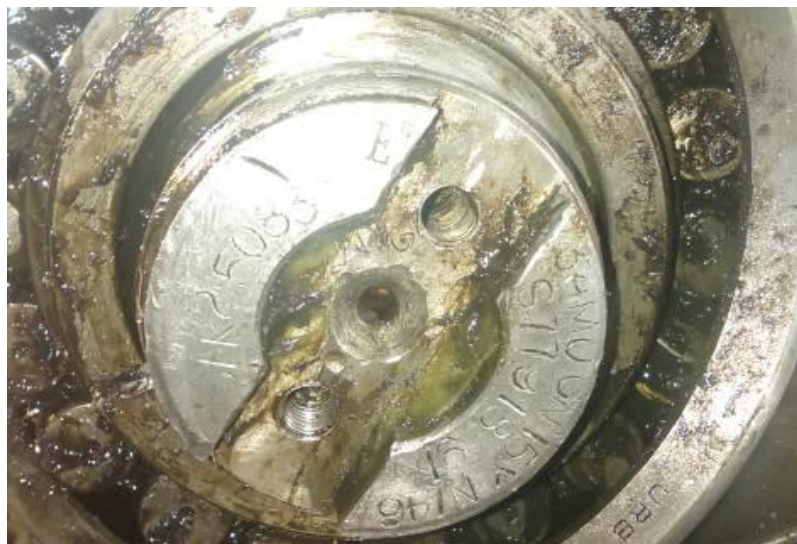
Picture no.3 – end of driving axle

- the driving axle has the stock number CFR 25083, resulting from the cast batch S 77918/91 series 46 and is made of material 34 MOCrNi 15X in 1991 (picture no.3).
