ROMANIAN RAILWAY INVESTIGATING BODY

INVESTIGATING REPORT

of the railway accident occurred on 07.04.2013 on the Branch
of the Regional Center for Operation, Maintenance and Repairs Timișoara,
between the railway stations Baru Mare and Pui.

Final Edition
18.07.2013

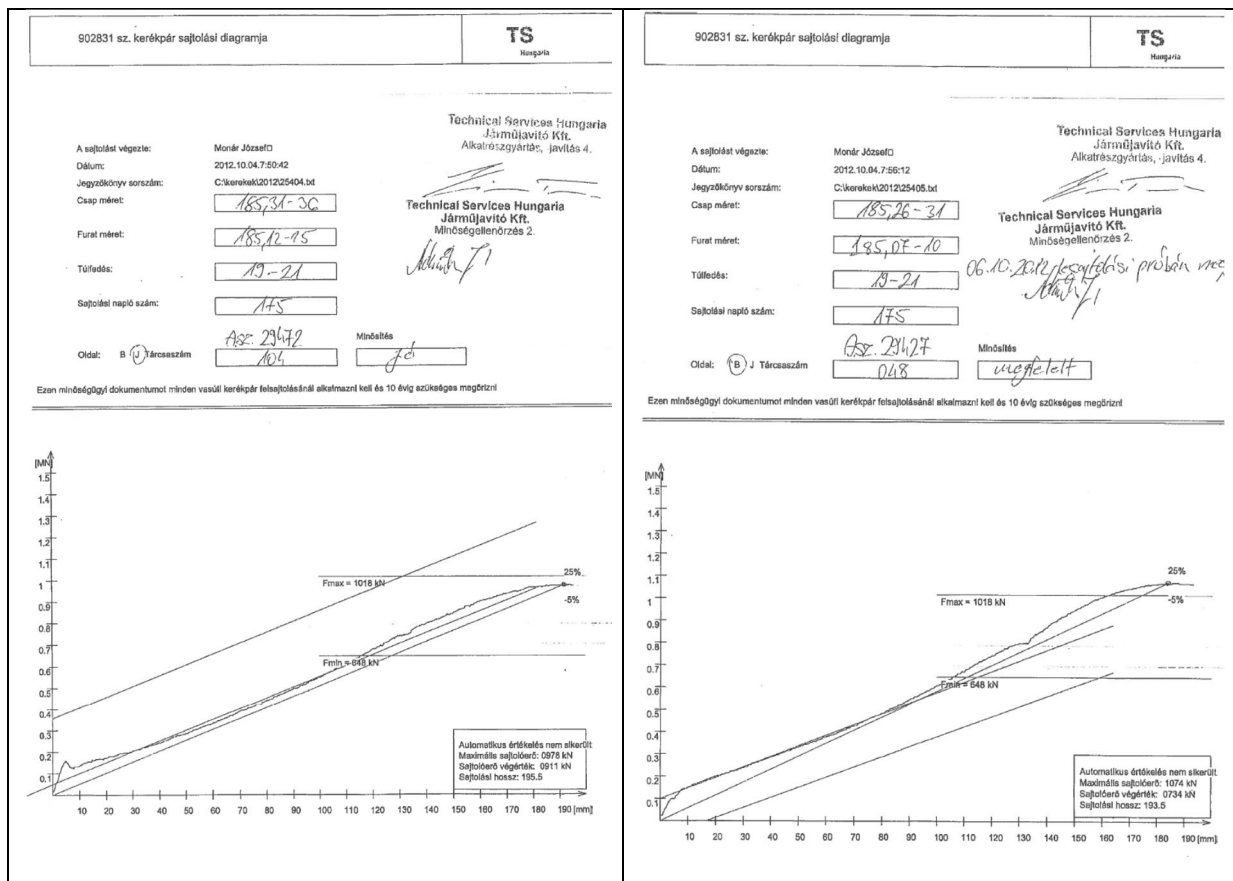
photo no. 4

- The manufacturer of the wheels fitted on the axle with series 902831 is Bonatrans, data of fabrication:07.2007;
- The number of the batch of wheels is 29427/048 and 29427/104;
- The axle with series 902831 was fitted on 04.10.2012 in the Miscolec workshop, the charts for assembling the wheels on the axle are presented in photo no.4
