INVESTIGATING REPORT

of the railway accident occurred on 07.04.2013 on the Branch
of the Regional Center for Operation, Maintenance and Repairs Timișoara,
between the railway stations Baru Mare and Pui.

Final Edition
18.07.2013

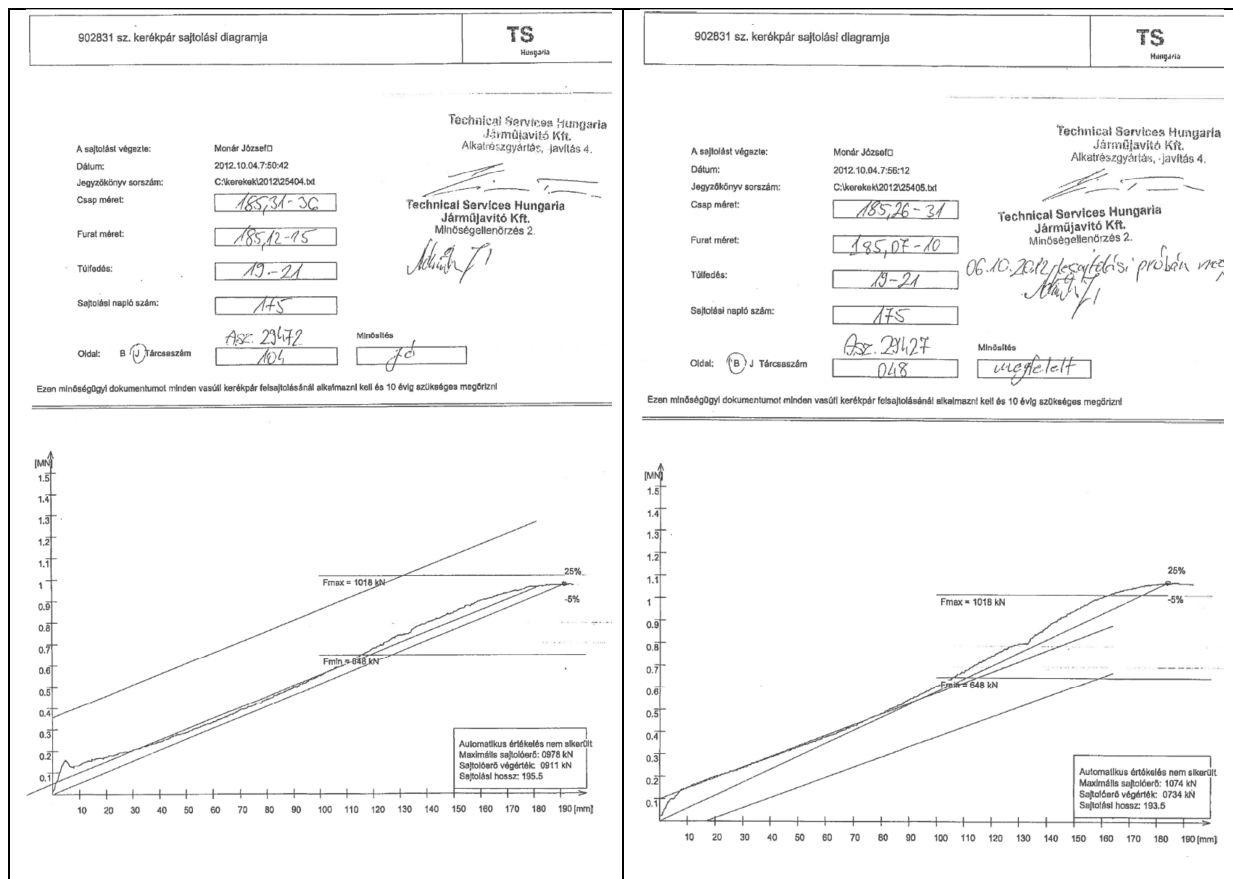
photo no. 4

- The manufacturer of the wheels fitted on the axle with series 902831 is Bonatrans, data of fabrication:07.2007;
- The number of the batch of wheels is 29427/048 and 29427/104;
- The axle with series 902831 was fitted on 04.10.2012 in the Miscole workshop, the charts for assembling the wheels on the axle are presented in photo no.4
